SUITE SUCCESS WASTE AUDIT REPORT 2018

Introduction

Suite Success Located at 411 Huronia Rd #5 in Barrie, ON obtained two employees from Busch Systems to perform a solid, non-hazardous waste audit at the main office. The audit was performed within the office with the primary goals of...

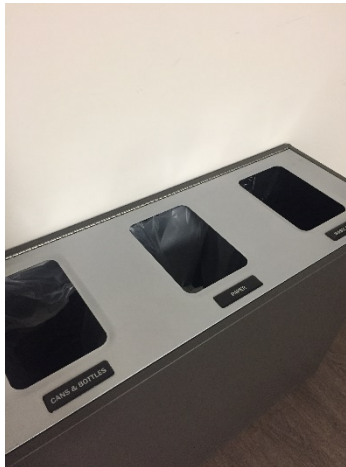
Figure 1- Event Room One Triple Aristata Station

- Improve signage, labelling and consistency throughout the building. There is inconsistent messaging on many of the containers, specifically the Plastics, Cans and Bottles streams. For example Event Room One says “Cans, Glass & Plastic” and “Trash Only”, while Event Room Two says “Cans & Bottles” and “Waste Only”. Ensuring consistent signage, educational posters and labelling throughout the building will reduce confusion at the bin, enhancing diversion rates and lowering contamination rates

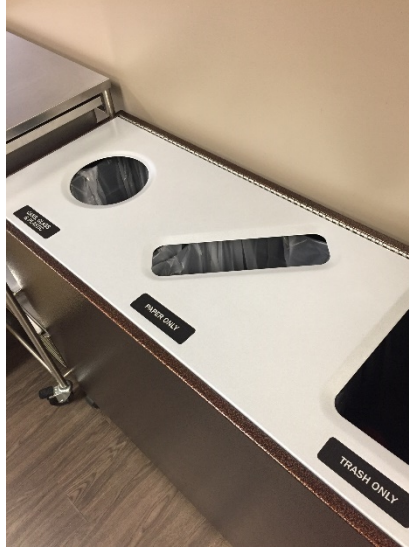
- Event room two just off the kitchen has a triple Aristata Station with a capacity of 15 gallons per stream for a total capacity of 45 gallons. The collected streams are labelled as “Trash Only”, “Paper Only” and “Cans, Glass & Plastic”. The container is placed against the wall immediately exiting the kitchen area and each stream has a restrictive opening.

Figure 2- Event Room Two Triple Arisitata Station

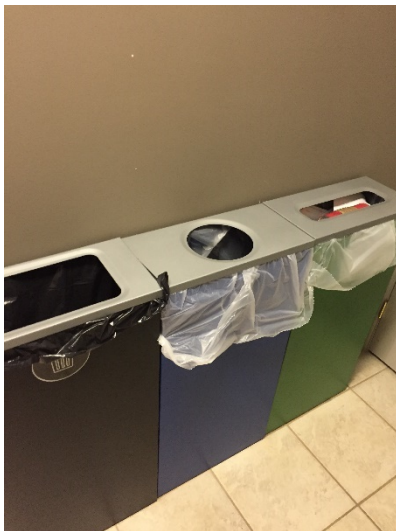
- By the Tenant offices there is a triple stream Spectrum Cube Slim station with a stream capacity of 10 Gallons, and total capacity of 30 Gallons. The labelling on the containers indicate A Waste, Mixed and Organics stream collection. The signage above the containers indicate a Plastic, Waste and Paper stream collection.

Figure 3- Tenant Station three Cube Slim Spectrums

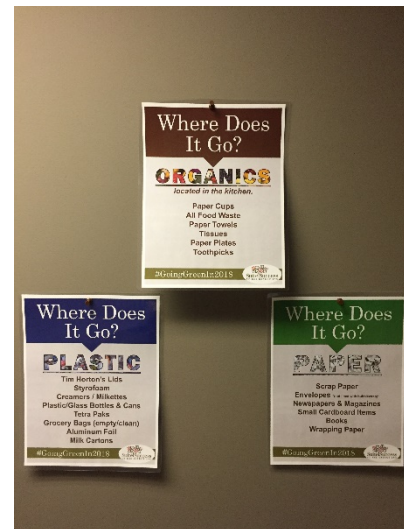
Figure 4- Signage located above the Tenant Spectrums

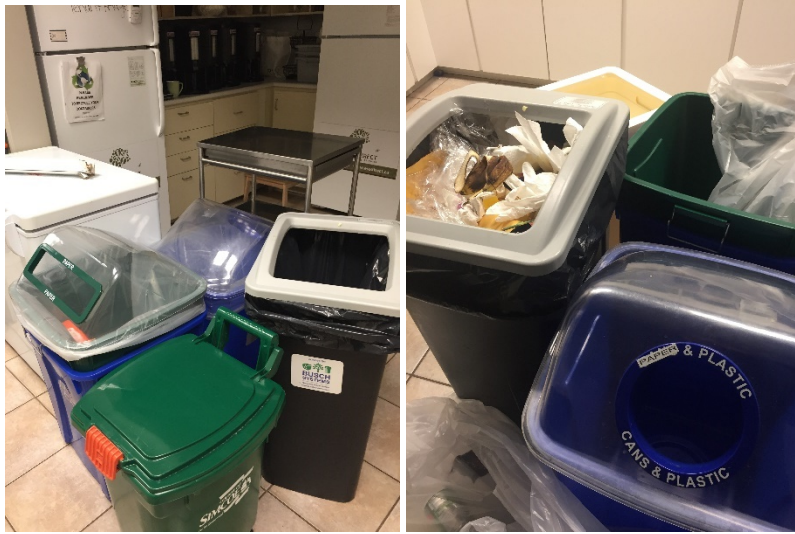
- The Lunch Room collected three streams at time of sampling “Waste”, “Paper”, “Cans & Plastic”. The capacities of these containers were not measured at the time of auditing. They were of varying shapes and sizes. Waste container was without labelling or signage, while the paper stream was nicely labelled with a restrictive opening. The Cans and plastic stream had a circular opening and was labelled with as “Paper & Plastic” on the upper ridge and “Cans & Plastic” on the lower.

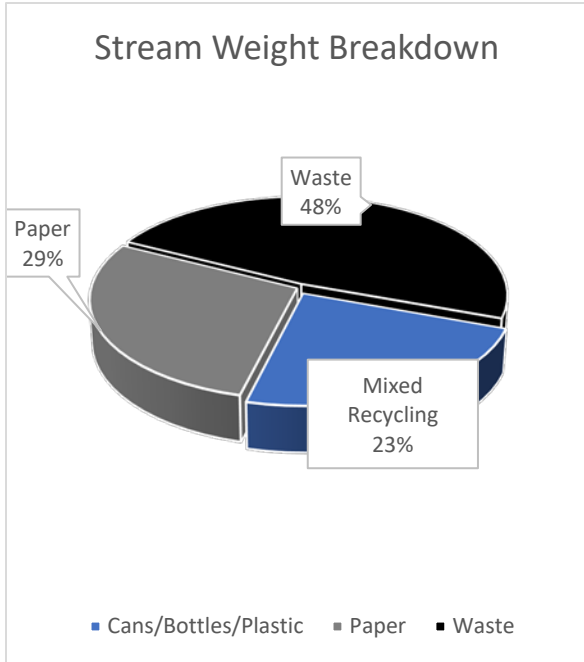
Figure 7- Represents the refuse breakdown by stream during the sample period, the largest of which was "Waste" (78%).

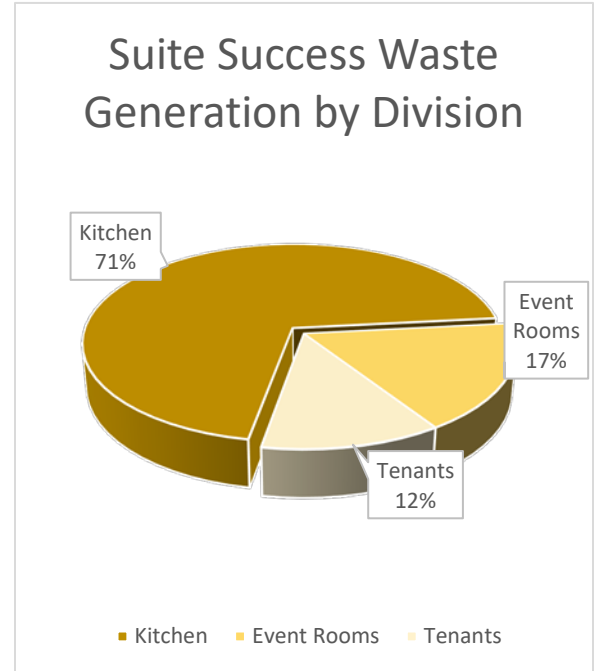
Figure 8 - Shows the breakdown of waste generation as a percentage by division.

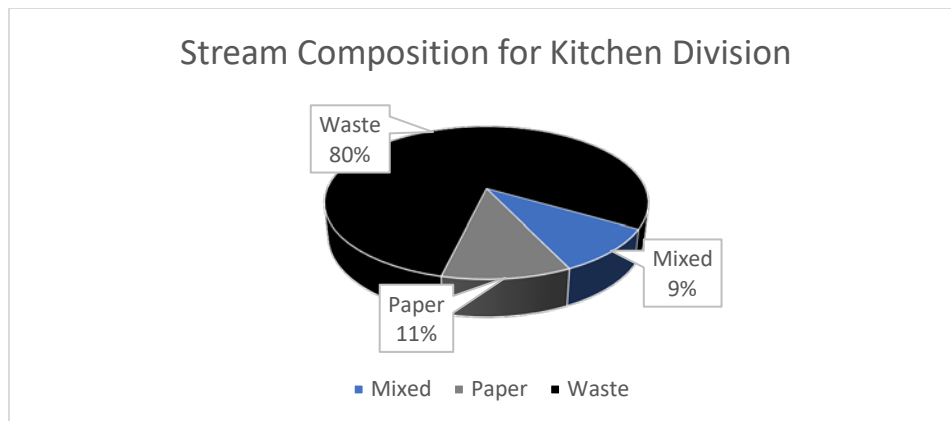
Figure 9- Shows the breakdown of each stream weight in the Kitchen Division during the audit. Waste is responsible for 93%

The kitchen within Suite Success has a three-stream system to capture all refuse discarded. With the absence of an implemented organic collection system, the kitchen diversion rate by weight takes a hard hit. If organics were removed from the waste stream and captured separately, the composition breakdown would look more like the following chart, with a diversion rate for the Division of 72% (up from 7%), bringing the total office diversion rate to 76% (up from 18%)

- Organic waste is responsible for 56% of Suite Success disposed items. By implementing an organic collection program that captures and removes these materials from the waste stream, the office diversion rate would increase to around to 76% (up from 18%).

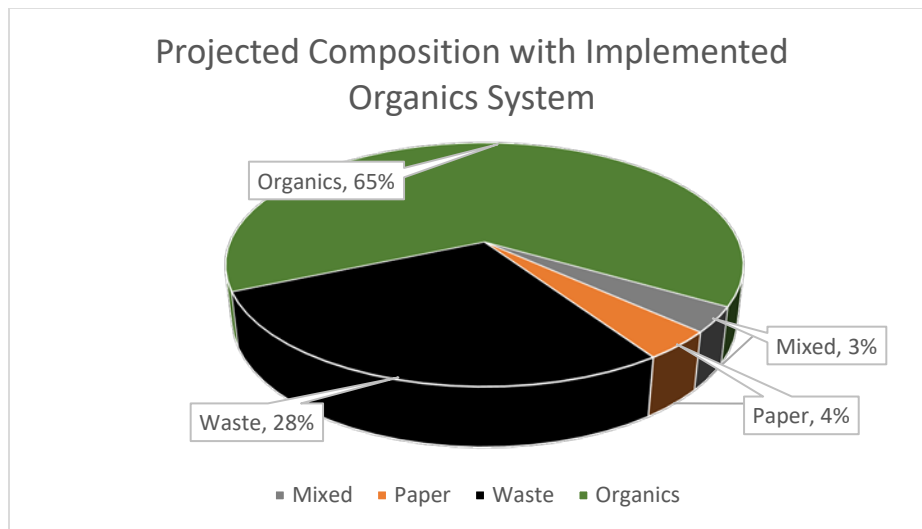
Figure 10- Shows the breakdown of each stream weight in the Kitchen Division should an organics stream have been present during auditing implemented. Waste would be responsible for 28% (down from 80%)

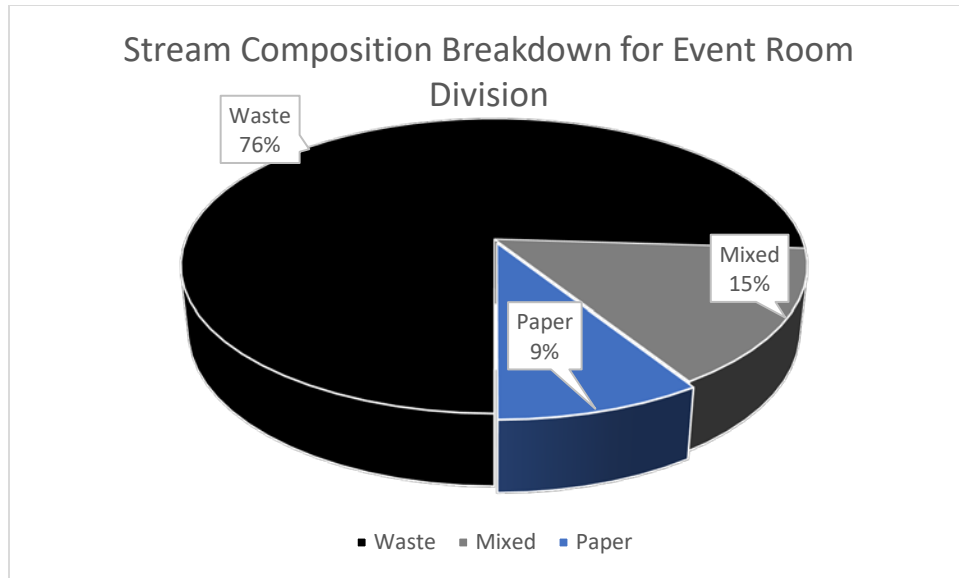
Figure 11- Shows the breakdown of each stream weight in the Event Rooms Division during the audit. Waste is responsible for 76%

Suite Success Event Rooms have some inefficiencies in its collection system, in particular with inconsistent signage, labelling and restrictive openings on containers leading to confusion and less-than-ideal diversion rates. While the "Mixed" stream only makes up 15% of the overall weight, the volume taken up by the materials is extensive. By far the biggest offender of which was the plastic packaging of catered events.

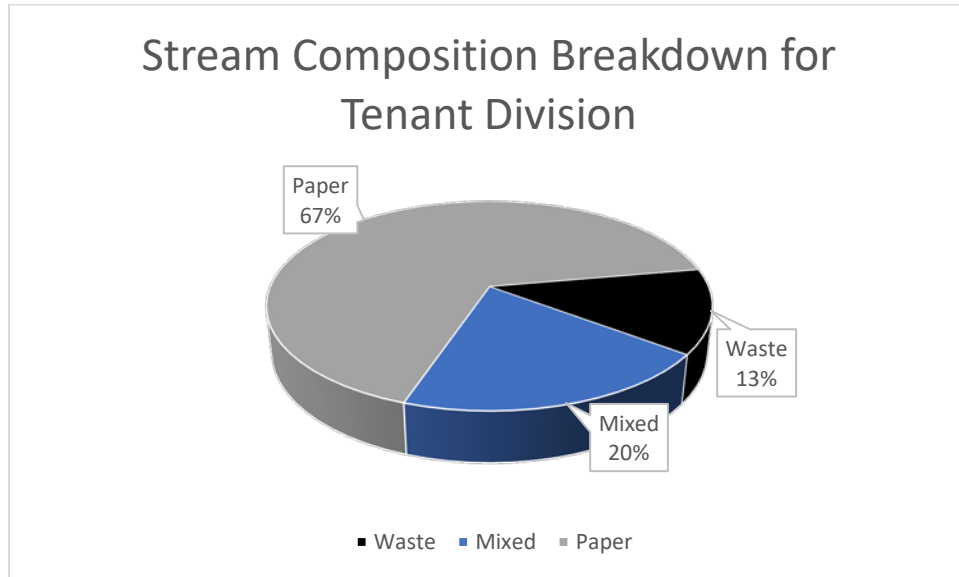
Figure 12-Shows the breakdown of each stream weight in the Event Rooms Division during the audit. Paper is responsible for 67%

Suite Success Tenant Division is by far the best performing division in terms of not only diversion rate, But also in contamination (after adjusting Kitchen Division for organic waste) with a 2.8% contamination rate. This is largely due to the large quantities of paper being disposed of, which is quite heavy in density.

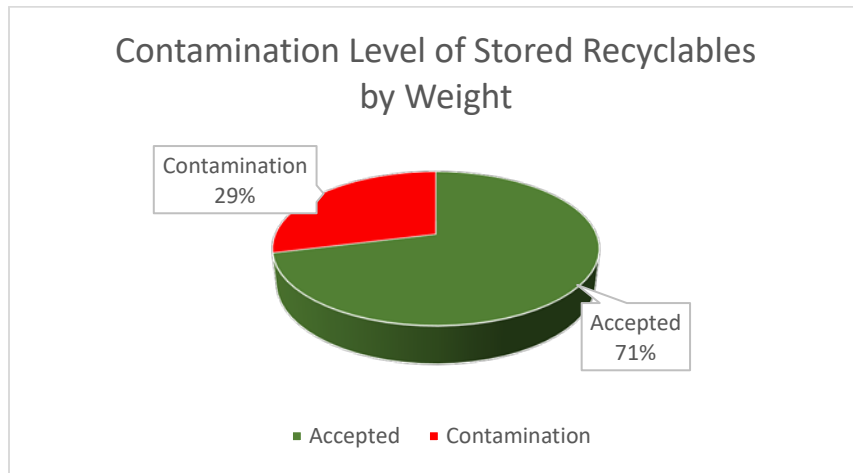
Figure 13- Shows the contamination level of the materials found in the Mixed Recycling bags that were stored over a weeks period.

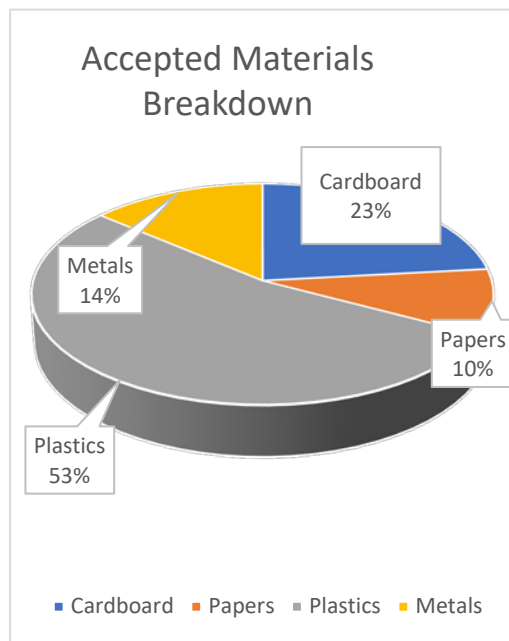
Figure 14- Shows the composition of materials that were accepted within the Mixed Recyclables stream, the highest of which was plastics (53%)

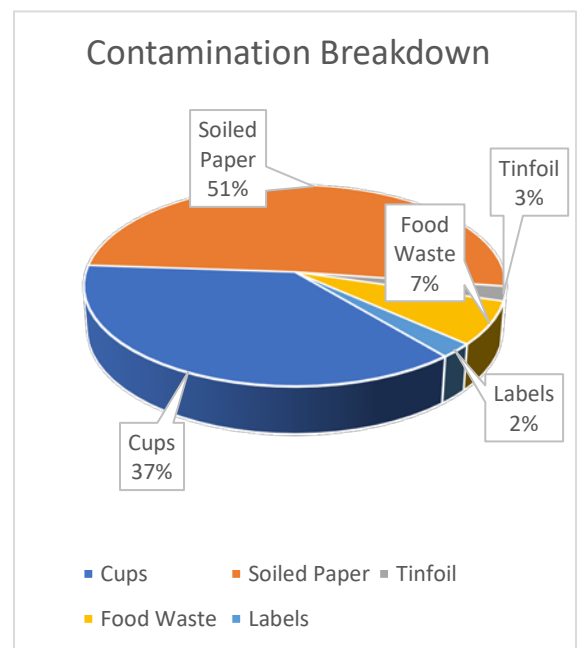
Figure 15- Shows the composition of materials that were considered contamination within the Mixed Recyclables stream, the highest of which was soiled paper (51%)

- After successful implementation of an organics system, consider sourcing for biodegradable, or fully recyclable, napkins, toilet paper and event refreshments/food packaging. Plastic Packaging accounts for approximately 11% of the offices disposed of items. while toilet paper and paper towel account for nearly 75% of the items incorrectly sorted in the mixed recyclable bin.
